Wear Testing of Thermally Oxidised Tool Steel Specimens with α -Fe₂O₃ Layers

Deniz Yilkiran*¹, Daniel Wulff², Fahrettin Özkaya¹, Sven Hübner¹, Ulrich Holländer², Hans Jürgen Maier², Bernd-Arno Behrens¹

Abstract

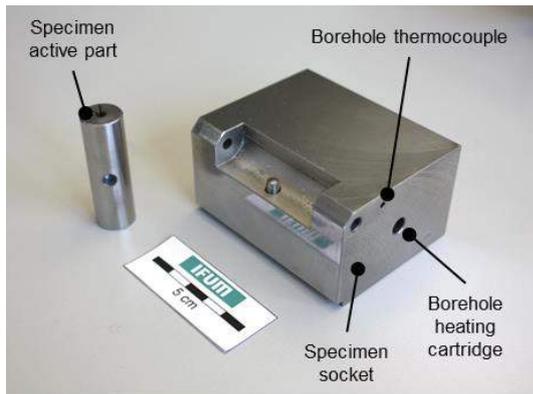
Fig. 1: Wear specimen including an active element (left) and a passive element (right)

The geometry shown in Fig. 1 was developed to ease non-destructive analysis (small active part), provide for economical benefits (separation of active and passive element) and allow for heating (with heating cartridges) and monitoring (with thermocouples) the temperature. By heating the 1.2379 tool steel specimens to $80\text{ }^{\circ}\text{C} \pm 5\text{ }^{\circ}\text{C}$ it was possible to quickly obtain stationary forming process conditions during the wear investigations. The temperature of about $80\text{ }^{\circ}\text{C}$ is also typical for commercial forming process with the high strength sheet material (DP600+Z in 0.96 mm) once stationary conditions have been reached. The resulting surface pressure between the specimen and the sheet

The experimental investigations were carried out on a wear test bench by drawing fresh unused material over the specimen's surface with every stroke. This method ensured conditions similar to a forming process in actual production where also fresh material is used for each stroke. A dedicated multiple part wear specimen geometry (Fig. 1) was used for the investigations. For details see Ref. [7].

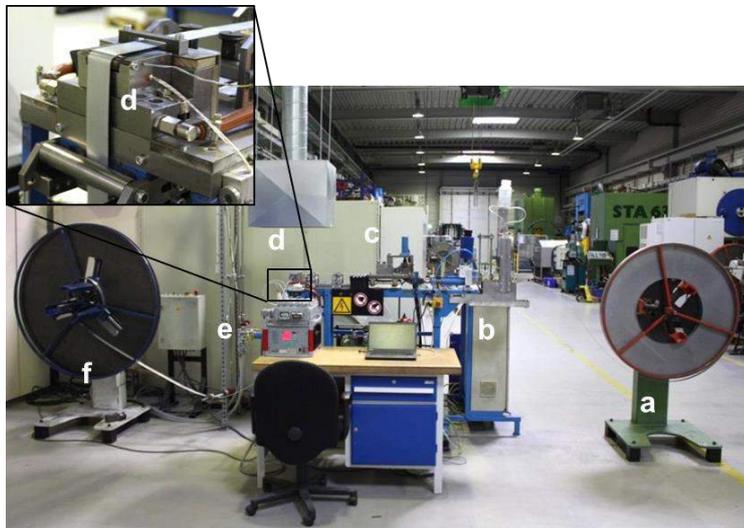
Fig. 2: left picture: Wear test bench with relevant units; a) decoiler, b) cleaning station, c) counter slide, d) specimen, e) pulling slide, f) coiler; right picture: principle of wear test bench

metal was determined by using pressure indicating films (Fujifilm HS - High Pressure Prescale) as reported in [6]. The wear specimen was mounted on the wear test bench shown in Fig. 2. The test bench is supplied with material from a coil. Fresh material is provided with each stroke from the decoiler (a). After decoiling, the material was cleaned from prelube oil (b). The drawing of the material over the drawing radius of the specimen (d) is realised on the test bench by using a counter (c) and a pulling slide (e). The counter force F_{counter} can be adjusted by the operator while the pulling force F_{pulling} is a resulting force which has to be higher than the adjusted counter force. In this way, the material is drawn over the specimens and finally fed to the coiler (f). During the forming process the forces as well as the displacements of the counter and pulling slide were recorded. For measuring the forces, a miniature load cell (HBM U9C) was used. The U9C load cell can be used for the measurement of tensile as well as compressive forces, which makes the set-up robust against backstrokes at the end of each cycle. The displacements of the counter and pulling slide were measured by using miniature wire sensors (Micro-Epsilon WPS-500-MK30).

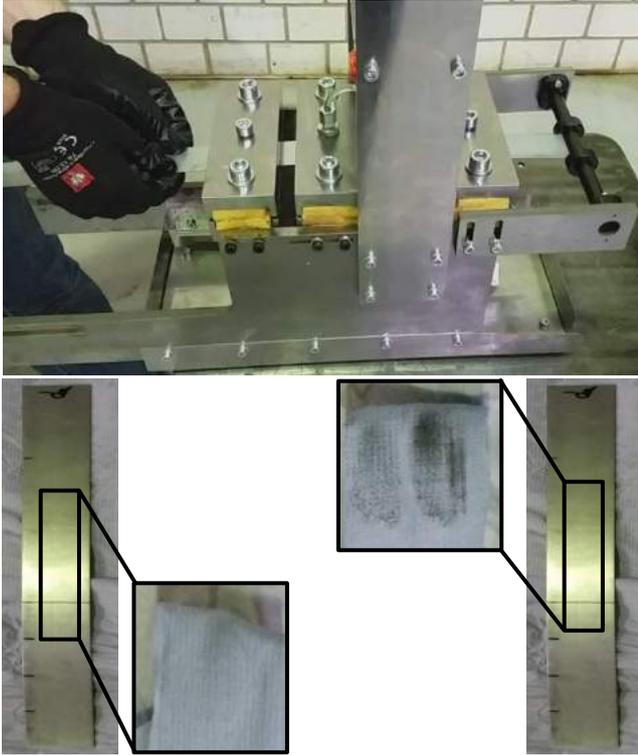
Fig. 3: Cleaning station without air nozzles (upper picture); wipe test before cleaning (bottom right picture); wipe test after cleaning (bottom left picture)

The wipe test, depicted in Fig. 3, shows the presence of significant macroscopic contamination of the sheet metal before cleaning. This can be attributed to the prelube oils which are used in commercial sheet metal production for corrosion protection. The wipe test in the left bottom picture shows a macroscopically clean sheet metal surface after passing the cleaning station within the first three cleaning steps. During the investigations the fresh material was continuously cleaned in the cleaning station. The cleanliness of the sheet metal surface was regularly manually checked with wipe tests. In case of detectable contaminations, the sponges of the station were cleaned or if necessary renewed.

For the present study, the material was cleaned from prelubes before forming (cf. Fig. 3). The cleaning station used purges the material in four stages from both sides:

The macroscopic contaminations present on the sheet metal before and after cleaning were examined with a wipe test as shown in Fig. 3.

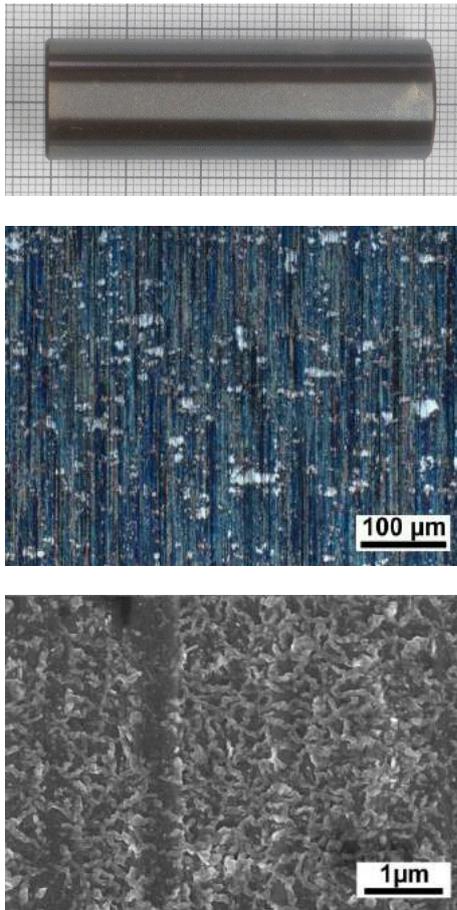
In Fig. 4 an untested specimen is shown at three magnifications. The top image in Fig. 4 shows an oxidised specimen with $\alpha\text{-Fe}_2\text{O}_3$ layer prior to testing. The whole surface of the specimen has a red/blue discolouration as a visible result of the surface oxidation [1]. A higher magnification with a light microscope (middle picture in Fig. 4) reveals that not all of the surface is covered with the oxide layer. The highest magnification in Fig. 4 (bottom image) reveals the microstructure of the oxide layer. The $\alpha\text{-Fe}_2\text{O}_3$ layer looks like an arrangement of long polymer chains. The layer is covering the largest part of the section shown, but there are also other uncoated areas.

The coverage of the surface with $\alpha\text{-Fe}_2\text{O}_3$ strongly depends on the local composition of the substrate. The investigated hardened tool steel (1.2379) has a high chromium content of approx. 12 wt.-% and chromium rich precipitations with different sizes could be detected by SEM-EDX. Surface areas that featured precipitations were usually not covered by the $\alpha\text{-Fe}_2\text{O}_3$ unless these were very small. Thus, it can be reasoned that the metallic sparkling areas in the top image of Fig. 4 are uncoated chromium rich areas.

Fig. 4: Selectively oxidised $\alpha\text{-Fe}_2\text{O}_3$ specimen. Top: photo of untested specimen; mid position: digital light microscopic image; bottom: SEM image

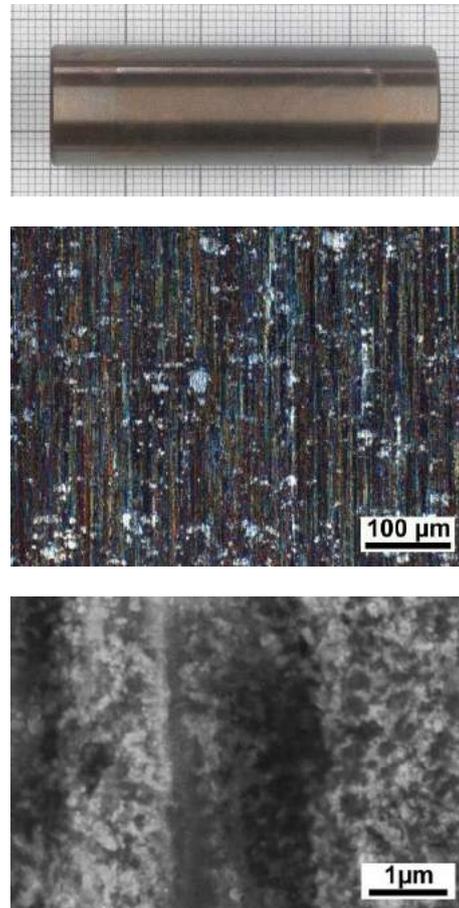
Depending on the number of test cycles the surface of the specimens changed after the wear tests. In Fig. 5 the tested specimen A1 is shown after 100 strokes. The photo (top picture) in Fig. 5 presents the macroscopic appearance of the specimen after testing. While in the bending area of the sheet metal (0° angle) a layer thinning can be seen, the evaluated area (45° angle) shows no significant changes on the surface on the macroscopic scale. In addition, slight marks on the left and right side in the contact area with the sheet metal can be seen in the photo in Fig. 5. These are results of the sheet metal burr cutting into the surface. This phenomenon is increasing with the number of strokes but not relevant in the present context because in commercial deep drawing operations such contact conditions are not present.

The light microscopic image of specimen A1 (middle image Fig. 5) only shows slight changes as compared to the light microscopic image of the untested specimen (Fig. 4). Only a few additional scratches along the sliding direction (vertical in the image) can be seen. Furthermore metallic sparkling areas are now visible and it seems that the size of these areas has also increased. It can be assumed that their higher fraction is a result of a partial removal of the $\alpha\text{-Fe}_2\text{O}_3$ structure. The $\alpha\text{-Fe}_2\text{O}_3$ also covered the edges of chromium rich precipitations. This leads to the conclusion that the increased fraction of the oxide-free areas can be reasoned by the reduced bonding of the oxide to the substrate at these chromium rich areas. In the SEM image in Fig. 5 (bottom picture)

the surface appears very different, as compared to the SEM image of the untested specimen (Fig. 4). The structure of the oxide layer seems to be smoothed and rounded but is still visible.

Fig. 5: Selectively oxidised $\alpha\text{-Fe}_2\text{O}_3$ specimen after 100 strokes; top: photo of tested specimen; mid position: digital light microscopic image; bottom: SEM image

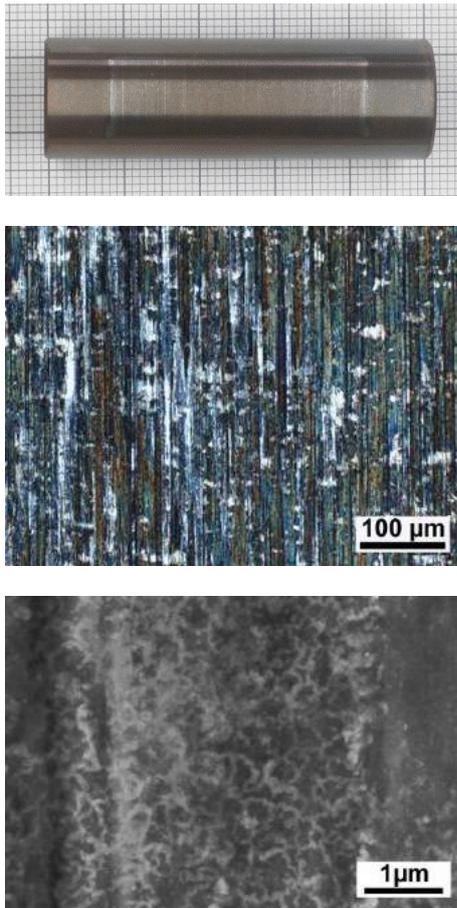
After a substantial increase of the number of strokes to 5000 a thinning of the $\alpha\text{-Fe}_2\text{O}_3$ layer can be seen clearly at each magnification (Fig. 6). The photo in Fig. 6 (top) reveals that the layer has become thinner over the whole contact area. But even after 5000 strokes a remaining layer can be seen clearly also in light microscopic image (middle). In addition to the layer thinning the middle image shows scoring in the drawing direction. Also zinc pick-up from the hot dip galvanized sheet metal used was detected by EDX. The SEM image in Fig. 6 (bottom) clearly shows features that are an evidence for the existence of $\alpha\text{-Fe}_2\text{O}_3$ on the surface.

Fig. 6: Selectively oxidised $\alpha\text{-Fe}_2\text{O}_3$ specimen after 5000 strokes; top: photo of tested specimen; mid position: digital light microscopic image; bottom: SEM image

Even after 5000 strokes of load (300 m of sheet metal) the friction reducing $\alpha\text{-Fe}_2\text{O}_3$ was still present on the surface, which indicates the potential of these coatings for demanding applications in dry metal forming.
